**ASTM F 1642-04/GSA TS01
TEST REPORT**

CUSTOM DESIGNED SYSTEMS, INC.

SERIES/MODEL: 3100

PRODUCT TYPE: Aluminum Pyramidal Skylight

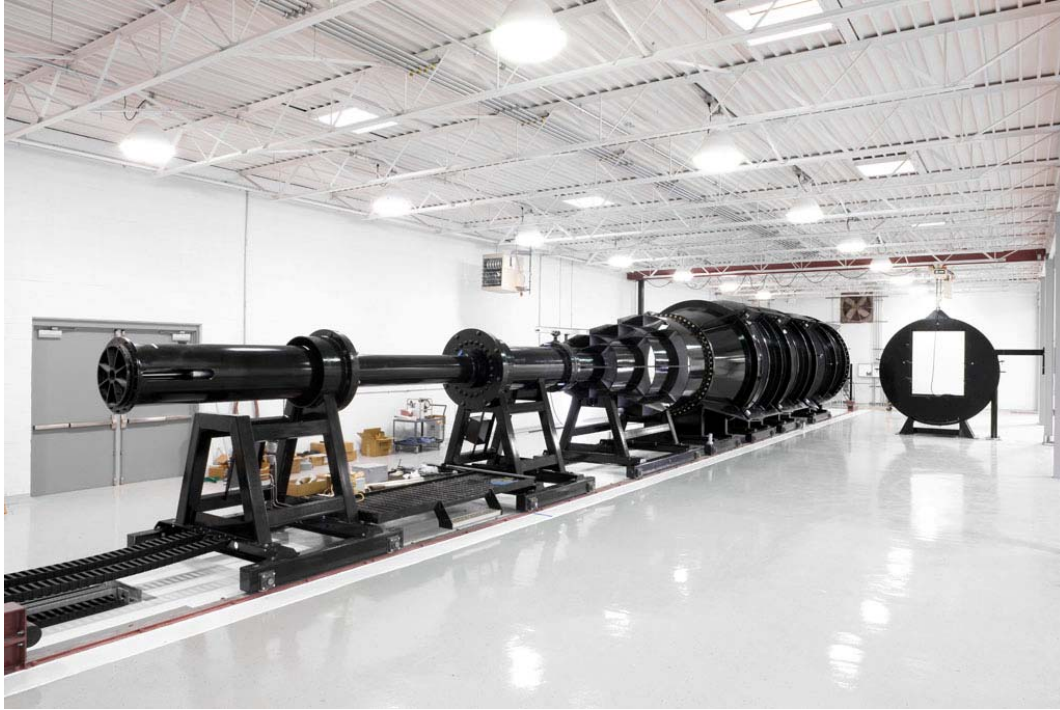
Figure #1
Shock Tube and Test Facility

Test Facility: Architectural Testing, Inc.'s shock tube is housed in a 10,000 square foot state-of-the-art test facility located in York, Pennsylvania. Blast loadings are produced on the specimen to simulate the effects of a high explosive charge at a specified standoff distance. Shock waves are generated by the sudden rupturing of a thin aluminum membrane. The shock wave expands as it travels down the tube, and impacts the target with a specific positive pressure and impulse. A photograph of the shock tube is provided in Figure #1 of Appendix A.

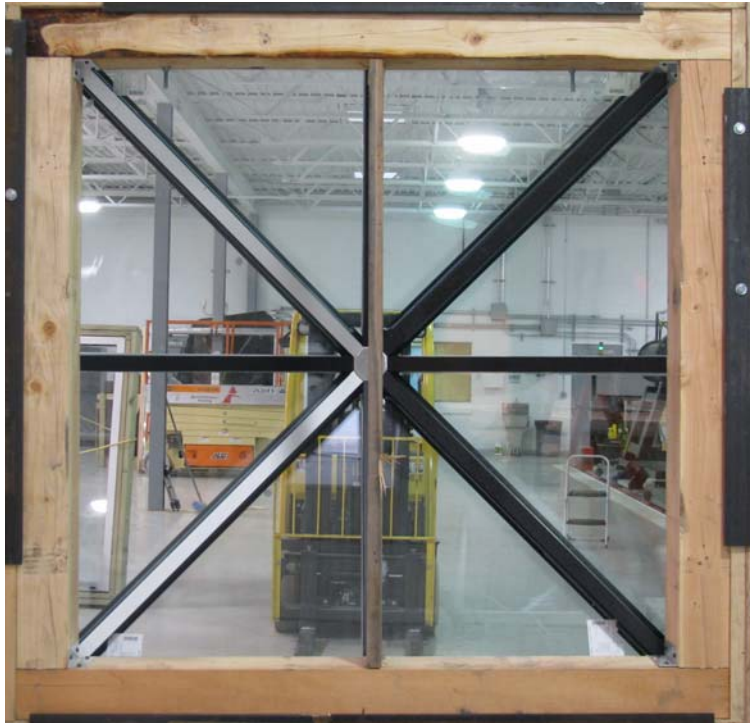
Photo No. 1
Pre-test Specimen #1, Interior

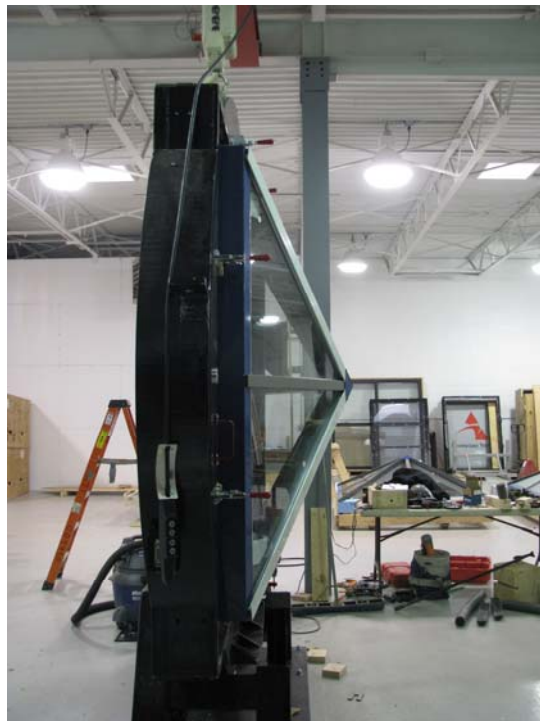
Photo No. 2
Pre-test Specimen #1, Side

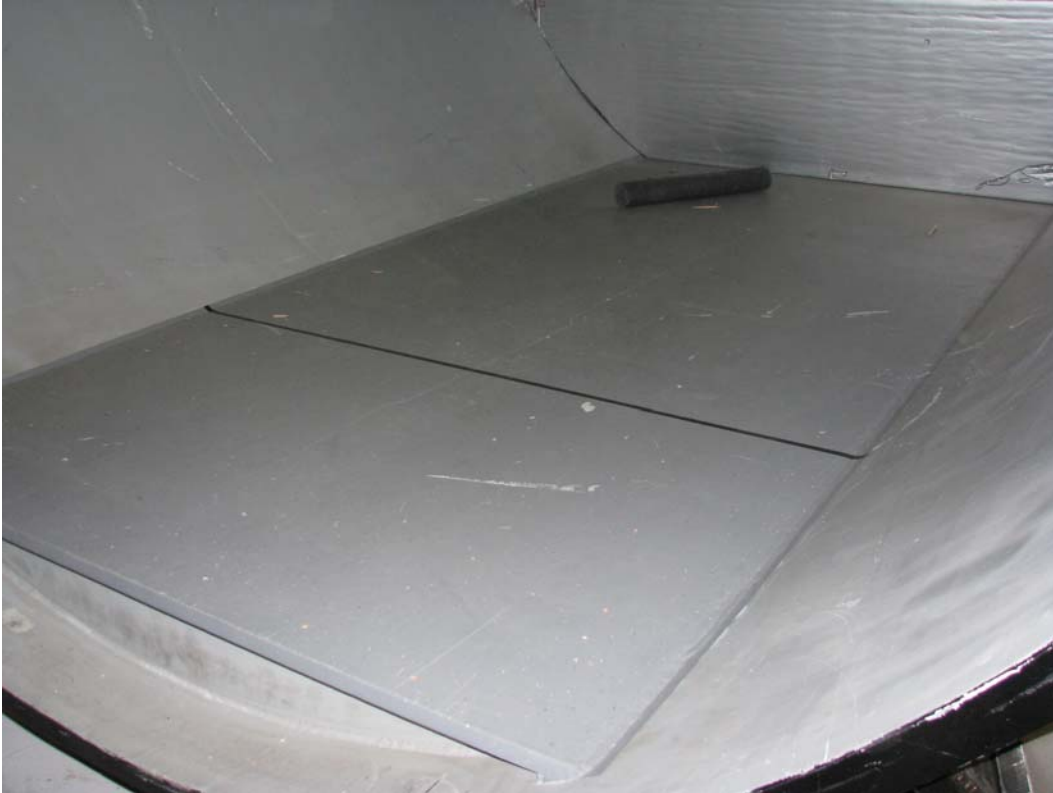
Photo No. 3
Post-test Specimen #1, Witness Chamber

- No pressure rise was measured on the protected side of the specimen.
- The exterior and interior lites remained unbroken. No visible frame damage was observed.
- No debris was observed.

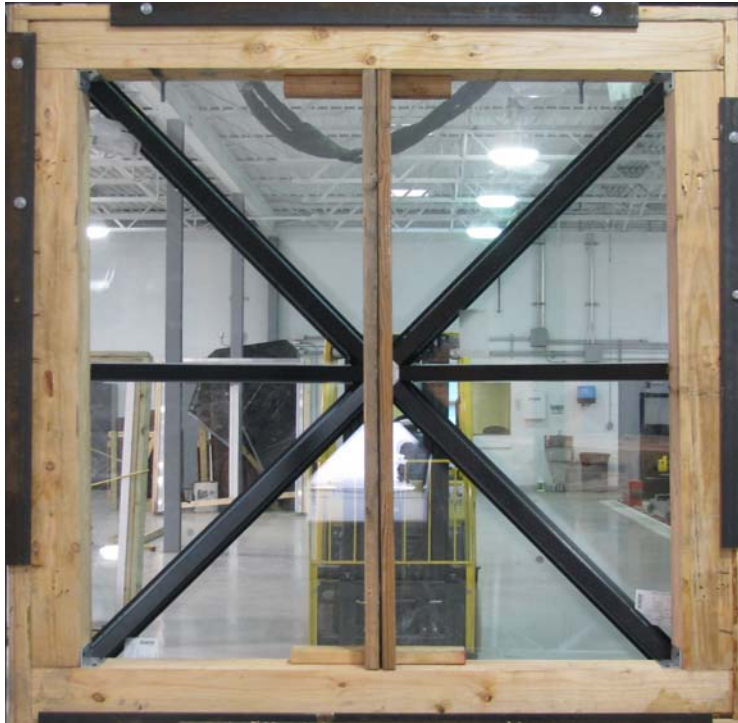
Photo No. 4
Pre-test Specimen #2, Interior

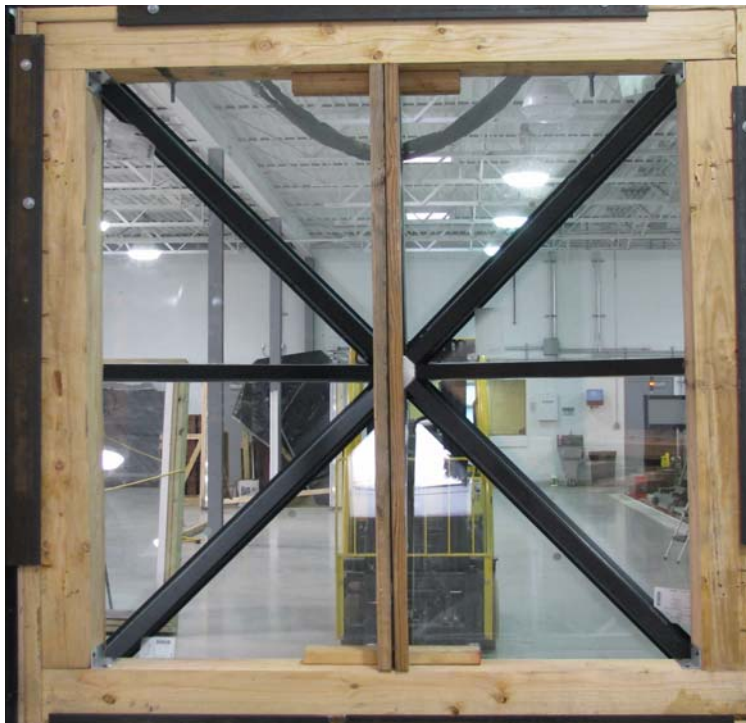
Photo No. 5
Post-test Specimen #2, Interior

- No pressure rise was measured on the protected side of the specimen.
- The exterior and interior lites remained unbroken. No visible frame damage was observed.
- No debris was observed.

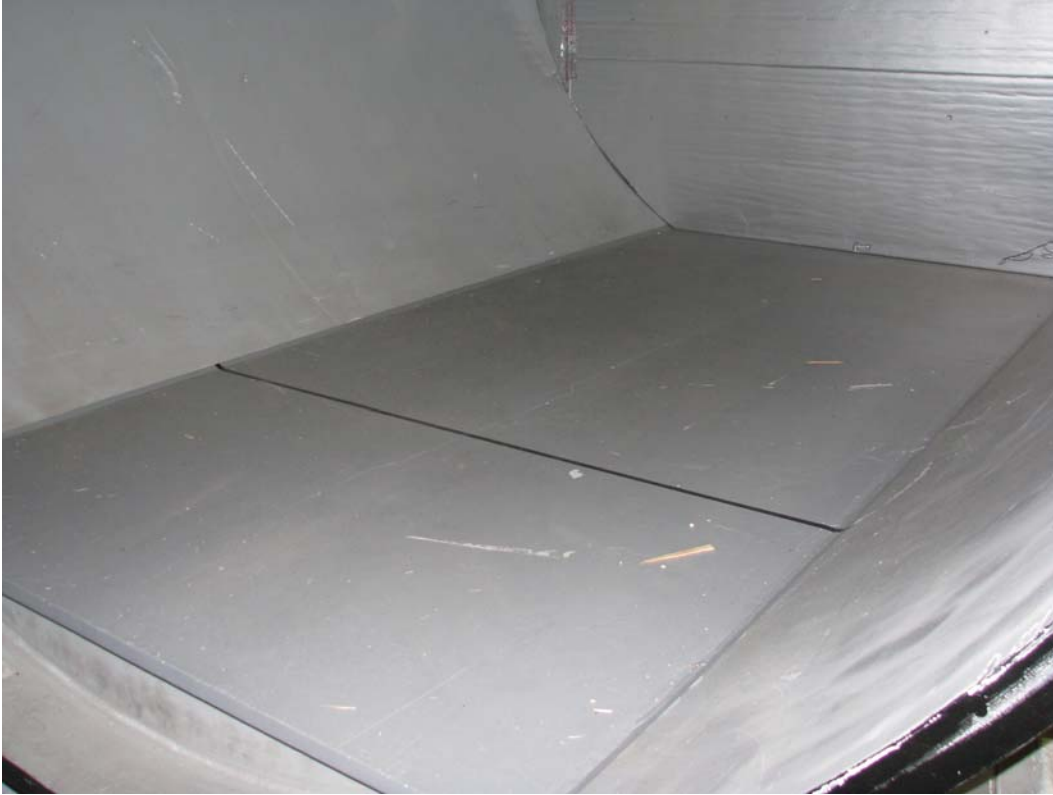
Photo No. 6
Post-test Specimen #2, Witness Chamber

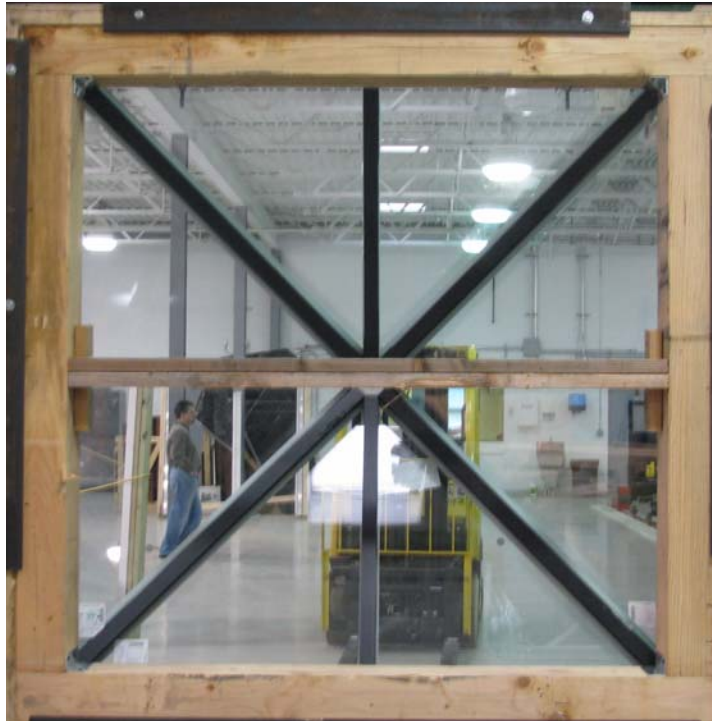
Photo No. 7
Pre-test Specimen #3, Interior

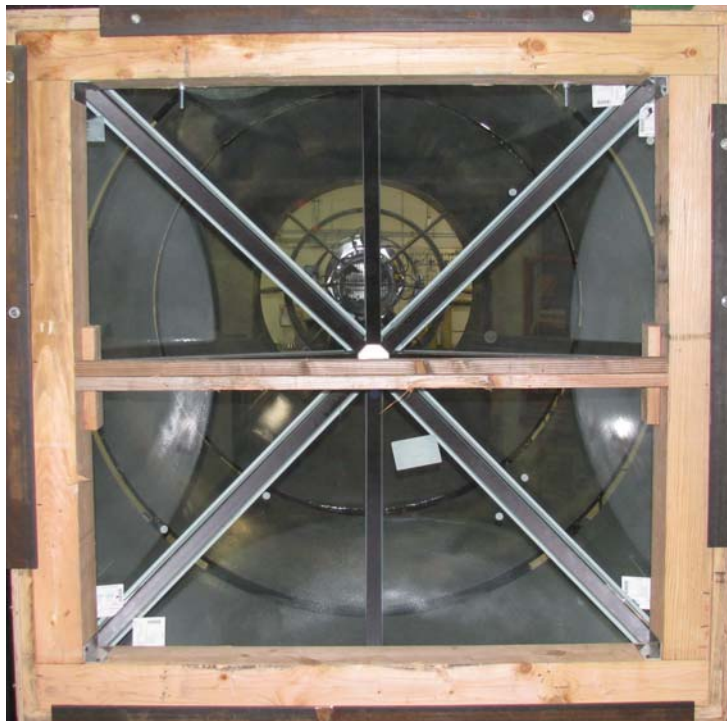
Photo No. 8
Post-test Specimen #3, Interior

- No pressure rise was measured on the protected side of the specimen.
- The exterior and interior lites remained unbroken. No visible frame damage was observed.
- No debris was observed.

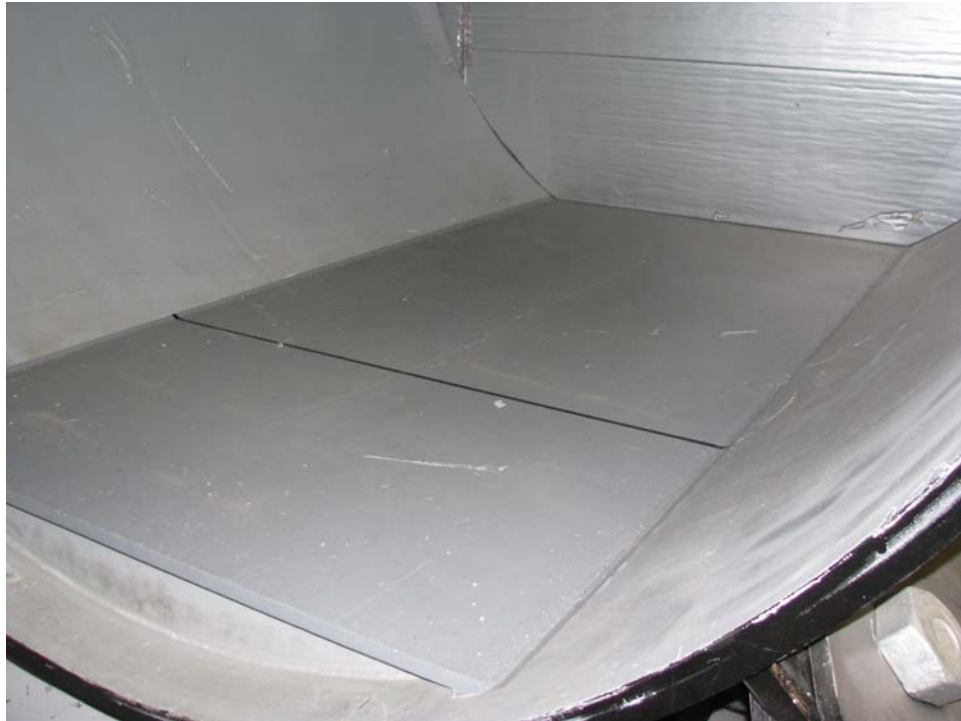
Photo No. 9
Post-test Specimen #3, Witness Chamber

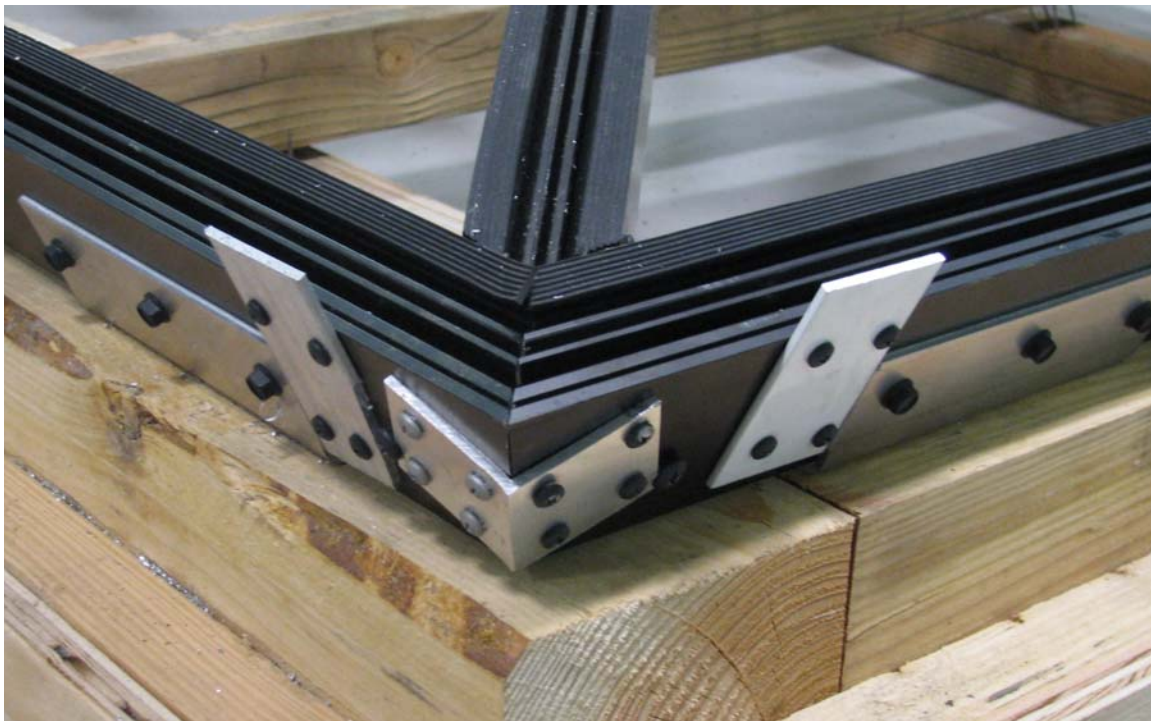
Photo No. 10
All Specimens, Corner Detail

Installation: The base frame members were attached to a 6-11/16" long brake formed 1/8" thick aluminum plates. The aluminum plates were attached to the frame with three #12 x 3/4" hex head self-drilling and tapping screws. The aluminum plates were attached to the simulated wood roof curb with two 1/4" x 3" long pan head screws per plate. Two plates were located at each corner and one plate was located at each rafter section.

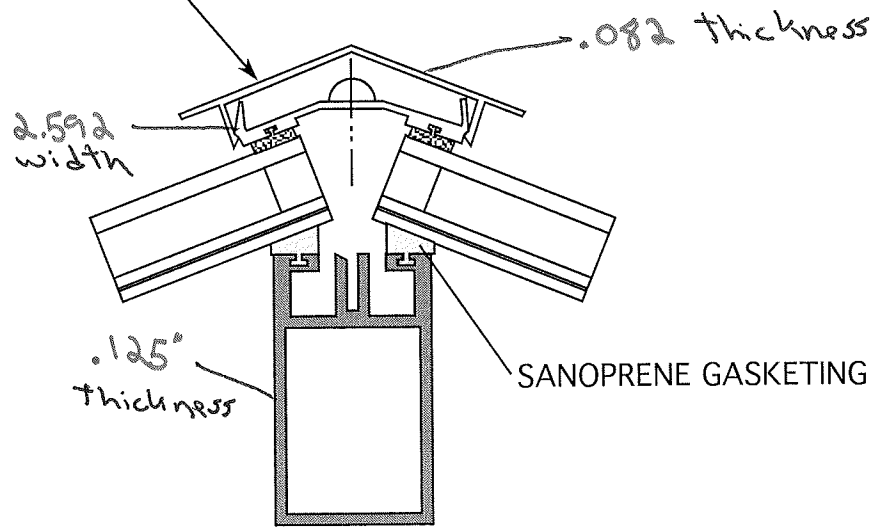
D HIP DETAIL

ALUM. HIP PRESSURE SYSTEM

1 3/16" INSULATED GLASS

Glazing Details: The window was glazed with a 1-1/16" thick insulating glass unit constructed of an exterior sheet of 1/4" thick tempered glass and an interior sheet of 7/16" thick laminated glass with a 13/32" aluminum spacer system. The laminated glass consisted of two sheets of 3/16" thick heat strengthened glass with a 0.060" PVB interlayer. The glass was set from the exterior against a rubber gasket and secured with a pressure plate and rubber gasket. The pressure plate was secured with #10 x 1-3/4" long screws spaced at 11" on center. A snap cover was fit over the pressure plate and a bead of silicone was applied to the pressure plate cover and the glass. A brake formed skirt flashing was applied around the perimeter of the glass at the base and was secured to the glass with adhesive tape and silicone sealant. A brake formed flashing cap was applied at the peak of the unit and secured to the hip and rafter sections with #10 x 3/4" pan head self-drilling and tapping screws. Glazing bite measured 5/8".
